⚠️ 🛠️ (E-1) Major Concern: SIDING AND TRIM REPAIRS NEEDED

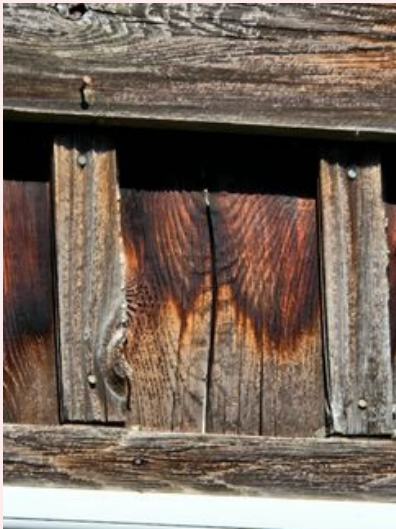
The south siding is splitting and could allow water entry

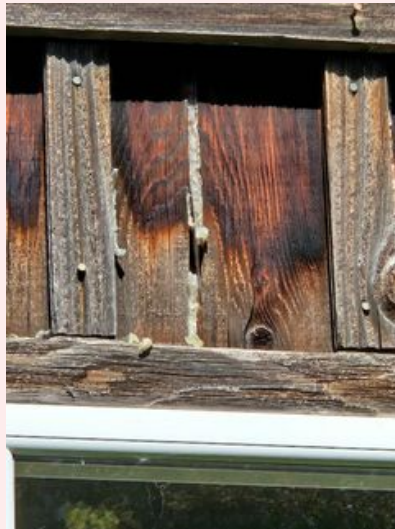
Sealant failure noted everywhere

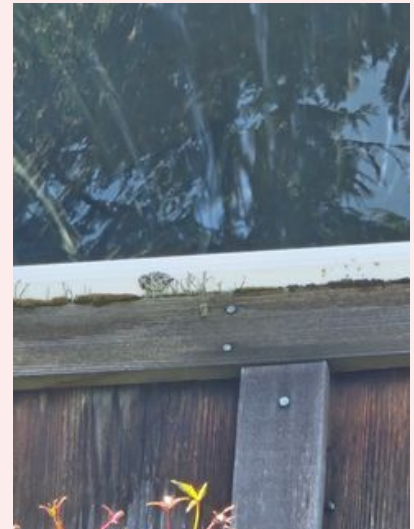
Organic growth noted at horizontal trim to siding junctures - this risks decay behind the trim

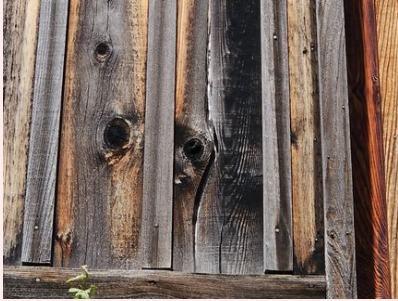
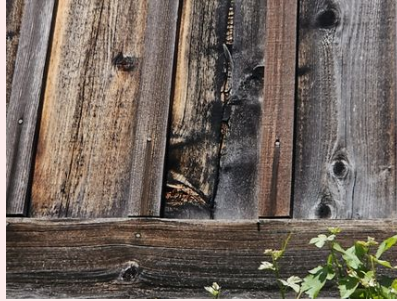
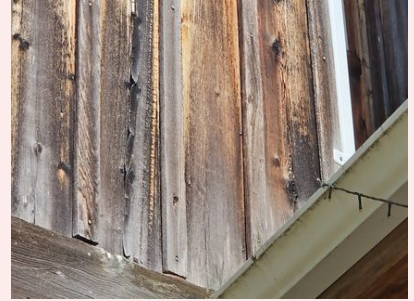
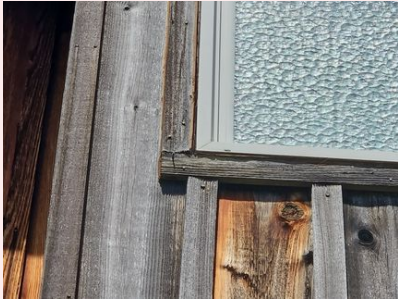
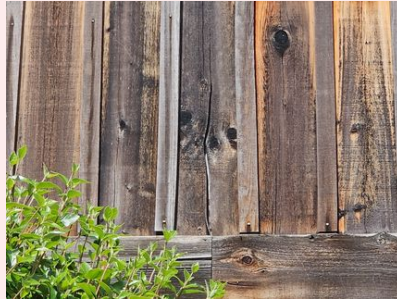
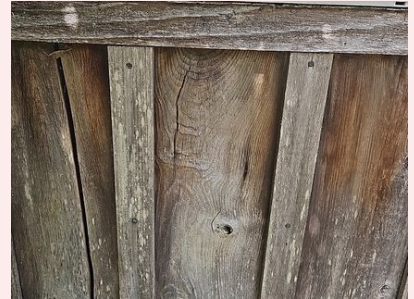
Some of the board and baton siding is splitting on the south side of the building. This has resulted in exposed weather barrier.

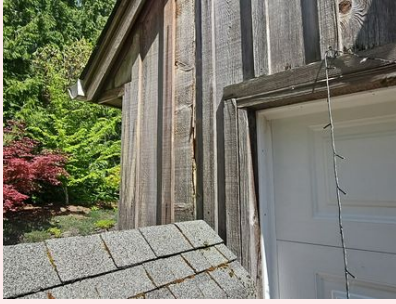
Damaged siding noted at the West face of the garage

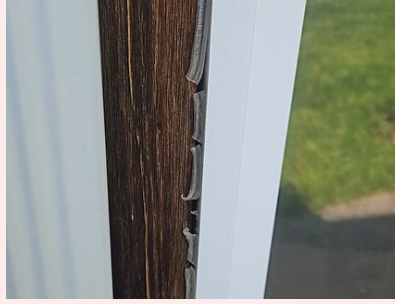
Failing a sealant noted between Windows and trim at the east side

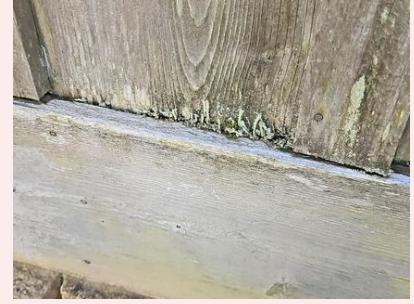
Water can get trapped between the trim and the siding. There is a risk of concealed decay and some of these details.

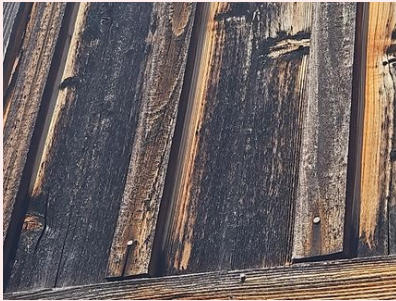
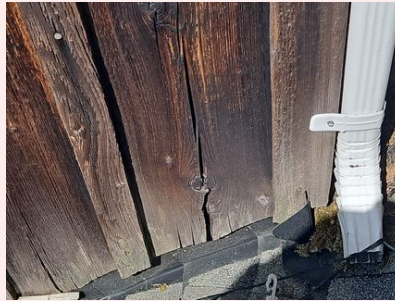
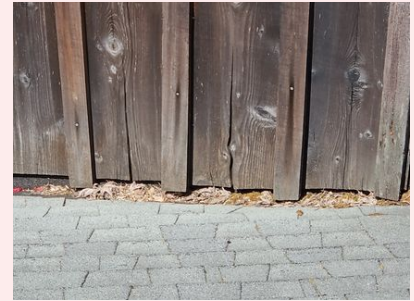
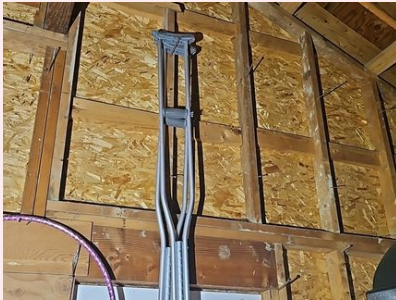
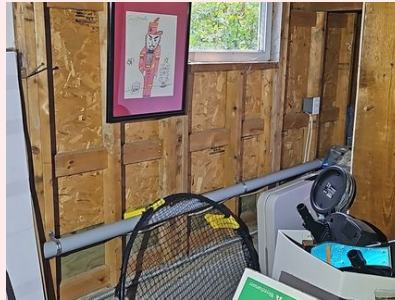
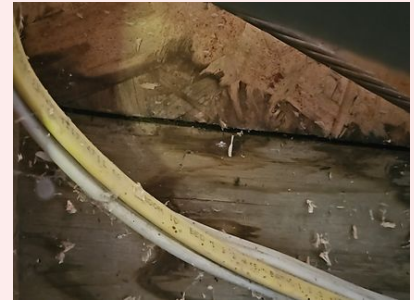
Water stains on the OSB sheathing beneath the electric panel are an indication that the siding could be leaking onto the sheathing in places.
