⚠️ 🛠️ (E-1) Major Concern: SIDING AND TRIM REPAIRS NEEDED

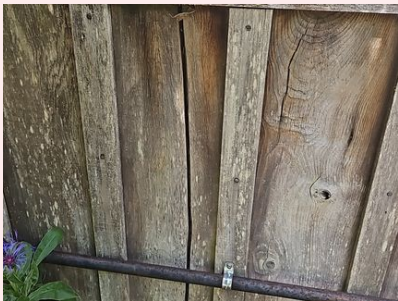
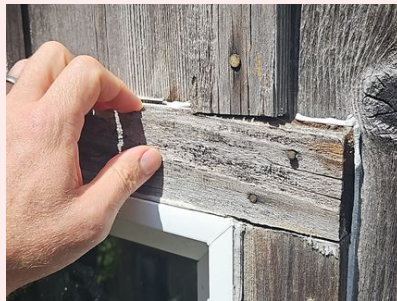
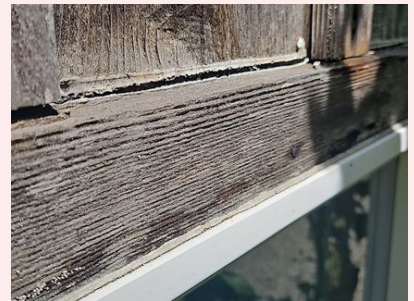
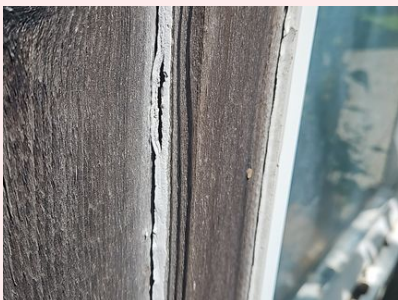
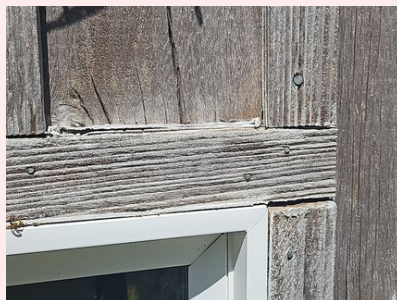
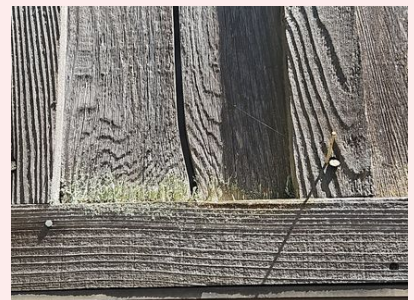
Some of the board and baton siding is splitting on the south side of the building. This has resulted in exposed weather barrier.

The siding system here has some beautiful details and is done with nice wood. The wood seems to be original to the build and has a beautiful patina. Unfortunately the siding is starting to deteriorate in expose locations. Cupping and splitting was noted on some of the wood as well as sealant failure especially where exposed to the weather. Repairs are needed to the exterior siding. It is difficult and somewhat subjective to determine the scope and urgency of needed repairs. Hire a licensed general contractor to further evaluate and repair as needed.
